# Building damage by the 2011 off the Pacific coast of Tohoku earthquake and coping activities by NILIM and BRI collaborated with the administration

Isao Nishiyama (NILIM),  
Hiroshi Fukuyama (BRI),  
Yasuo Okuda (BRI), and  
Izuru Okawa (BRI).

## 2. Building Damage due to Earthquake Ground Motions

# 3. Damage to Buildings in Inundation Areas due to Tsunami

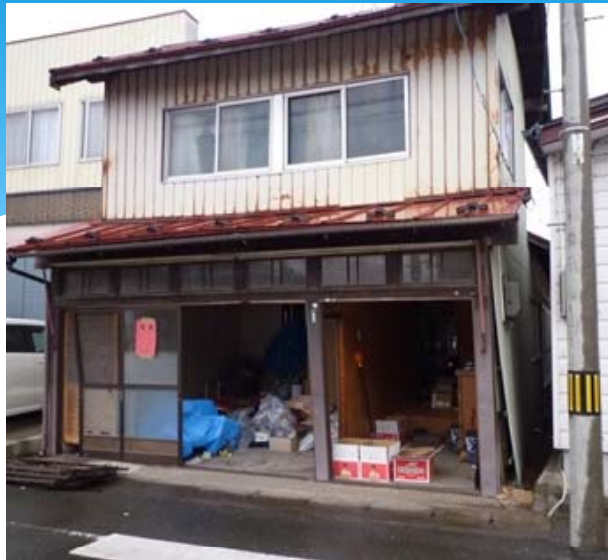
Damage of houses with store  
(Inclination of 1<sup>st</sup> story)

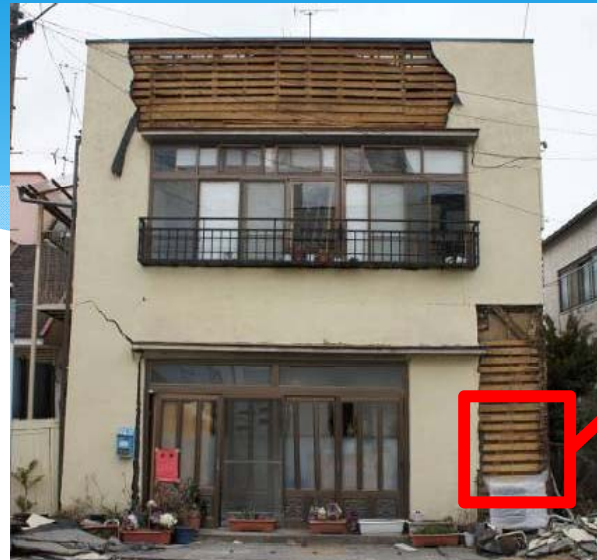
Damage due to  
Bio-deterioration

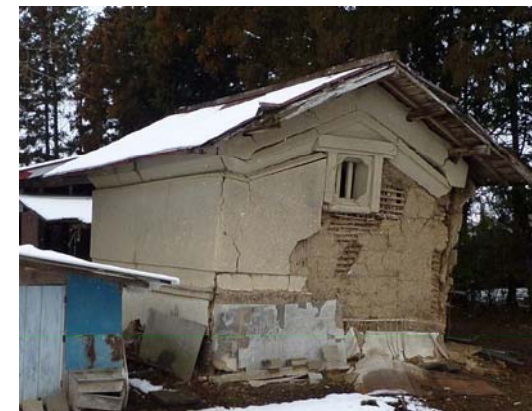
Damage of Dozo  
(Japanese traditional wood  
storehouse coated with  
clay and plaster finish)

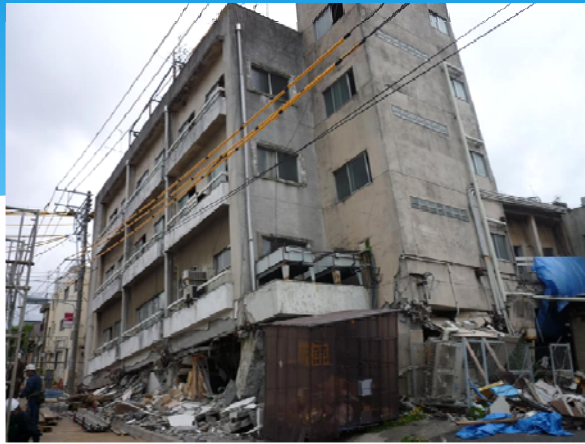
Collapse of soft-1<sup>st</sup> story by shear failure of columns

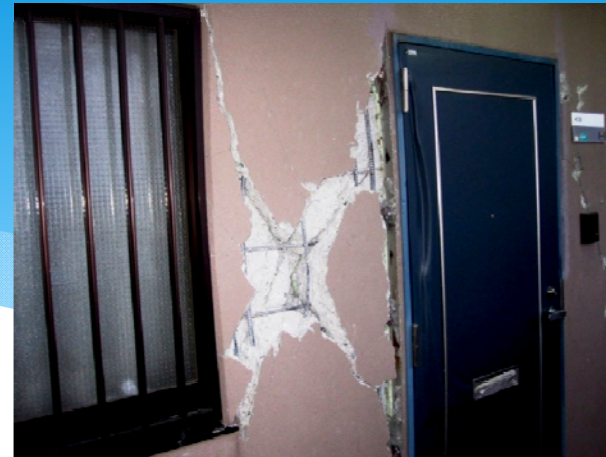
Shear failure of non-structural walls

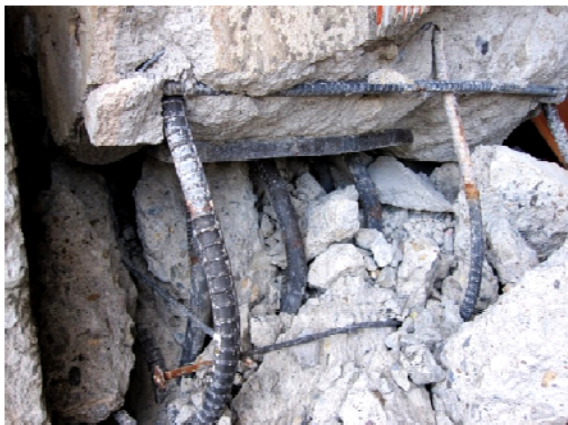
Pullout of anchor bolts of the exposed-type SRC column base

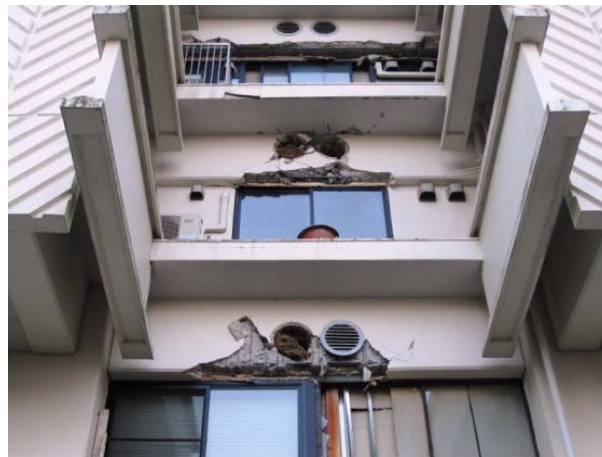
Shear failure of link-beam

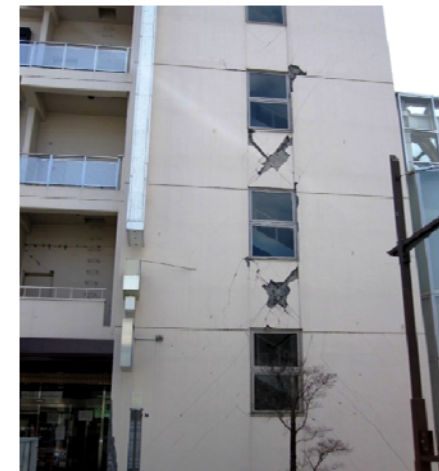
Shear failure due to opening of shear wall

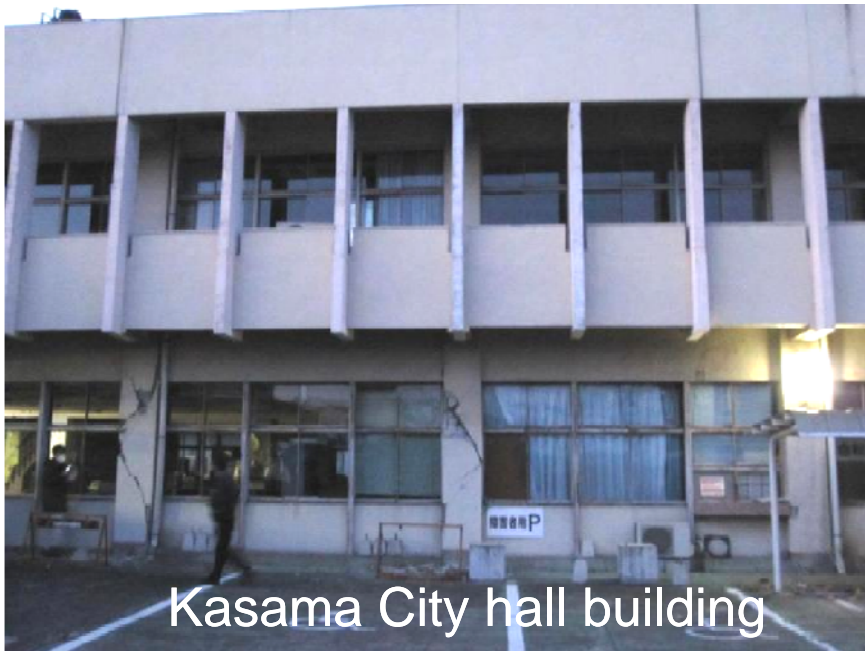
Kasama City hall building

- More than 10 local government office buildings designed by the old seismic code suffered from significant structural damage, shear failure of short columns and loss of axial load bearing capacity .  
These building could not be used as an emergency operation center.
- Damage mitigation for functional continuity is strongly required.

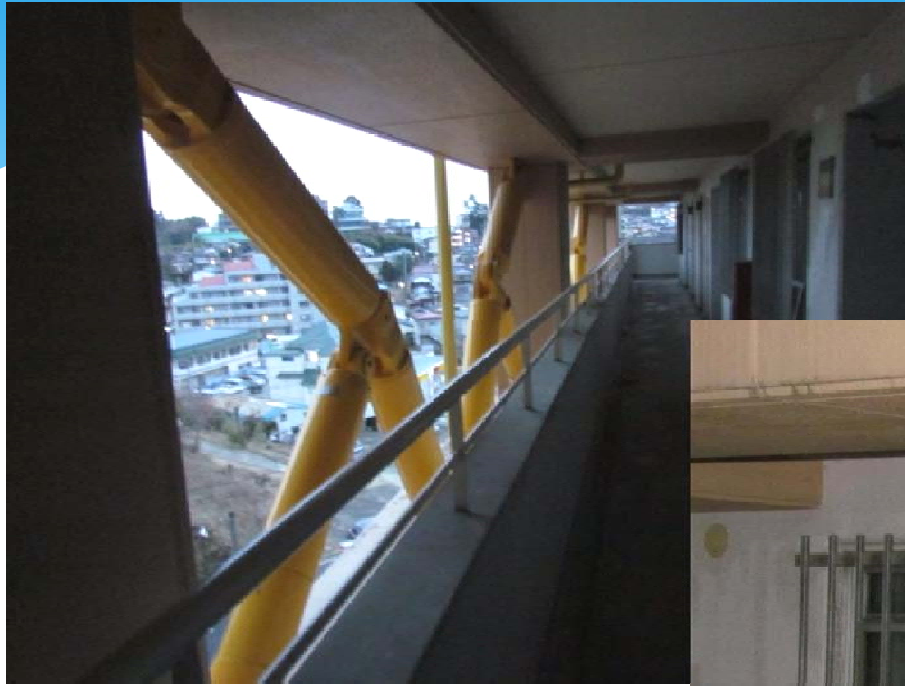
Damage to non-structural walls of residential buildings retrofitted by oil damper

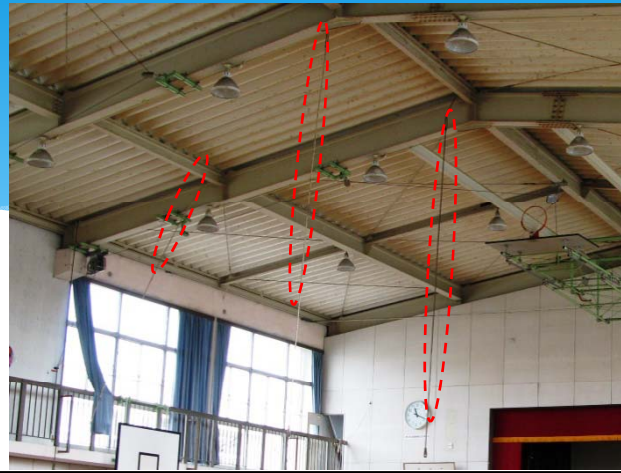
Rupture of horizontal brace

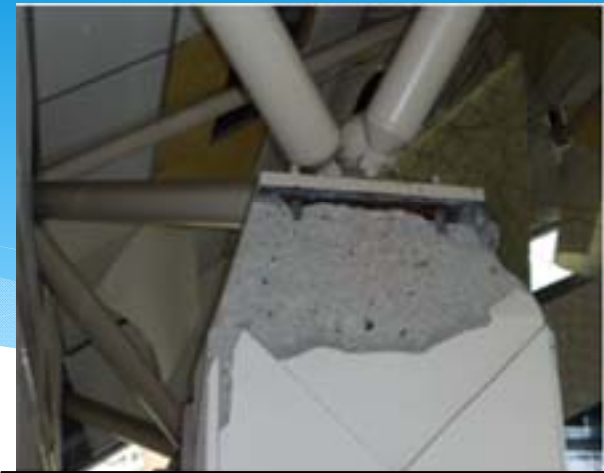
Spalling of concrete at joint

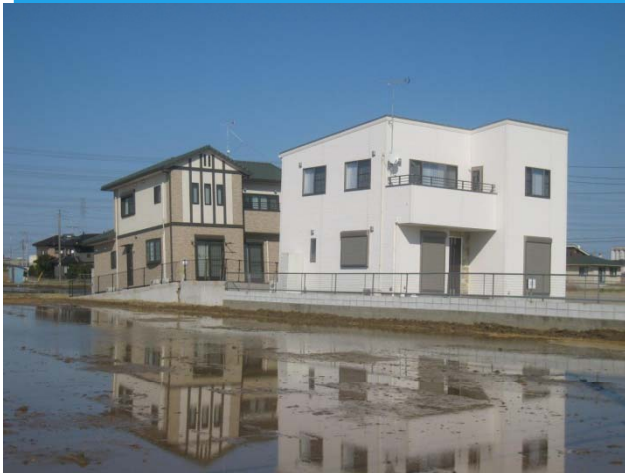
Large-scale liquefaction and settled or tilted structures

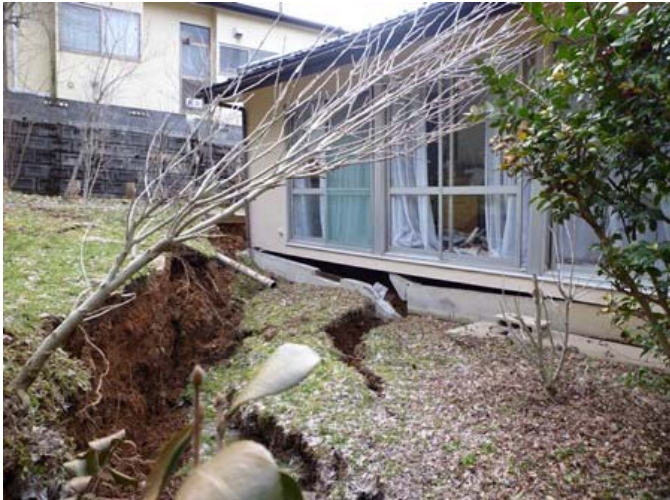
Failure of footing caused by the ground damage

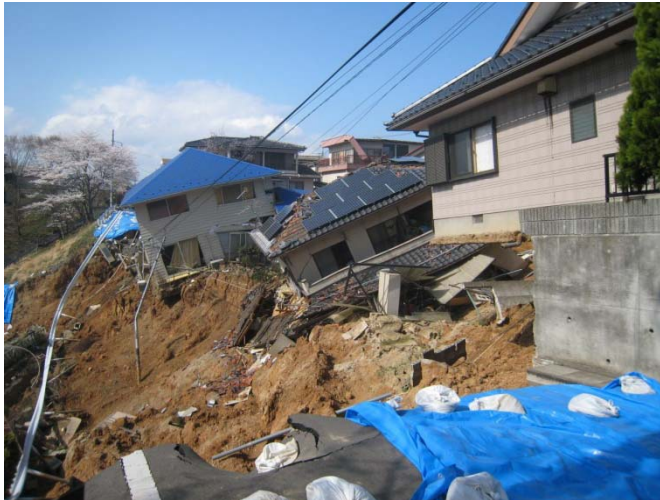
Land sliding on the slope of the developing hill

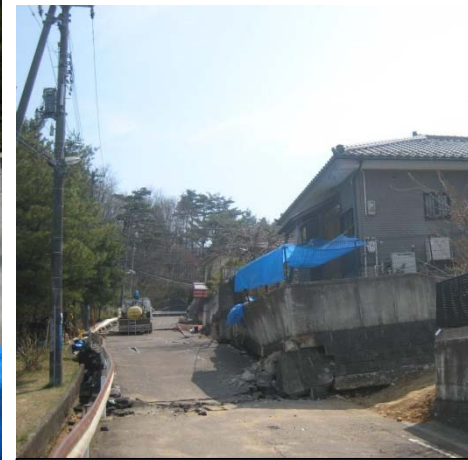
Damage of retaining wall and house movement

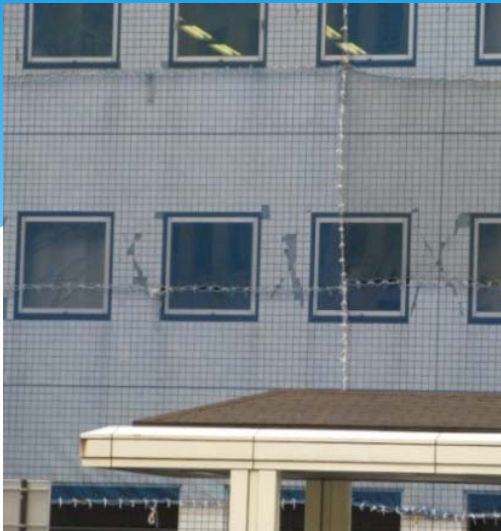
Cracking and spalling of tile

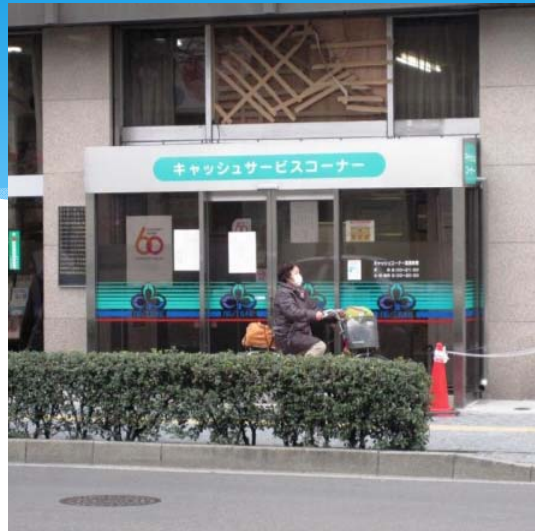
Failure of glass

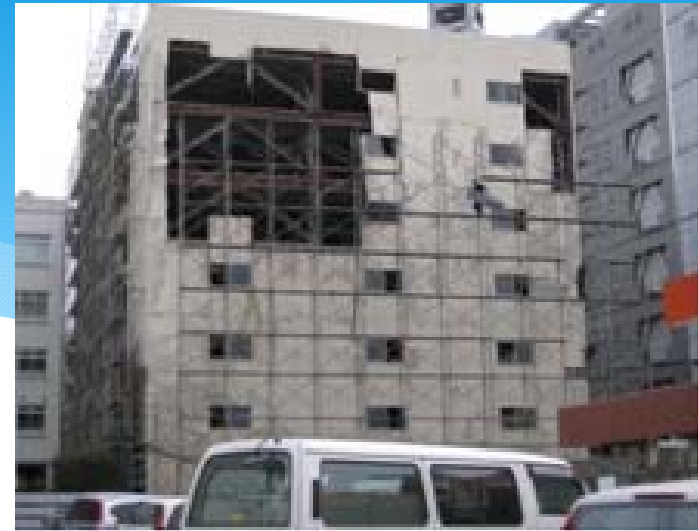
Fall of exterior wall panels

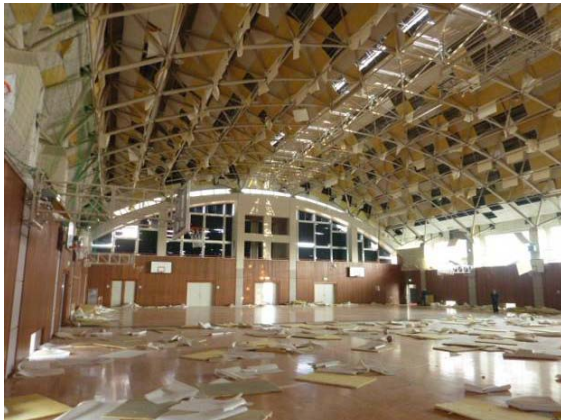
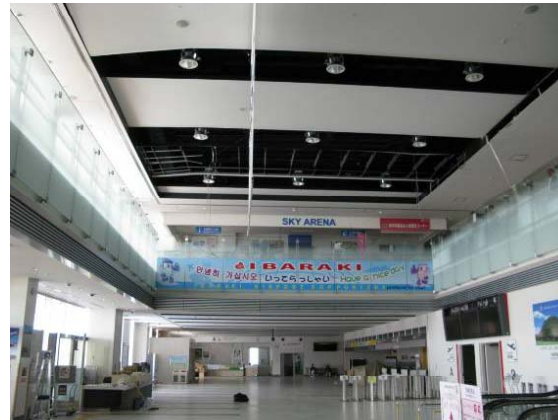
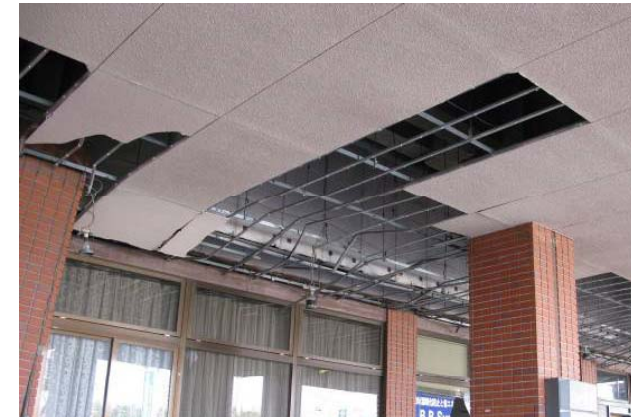
Damage and fall of suspended ceiling

However, **fall of suspended ceilings in large-scale spaces, liquefaction damage, and damper damage in seismically isolated building** are forced to take prompt measures.

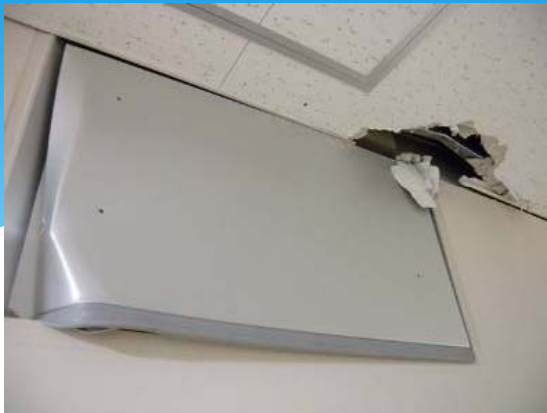
Damage to cover-panels for fire protection

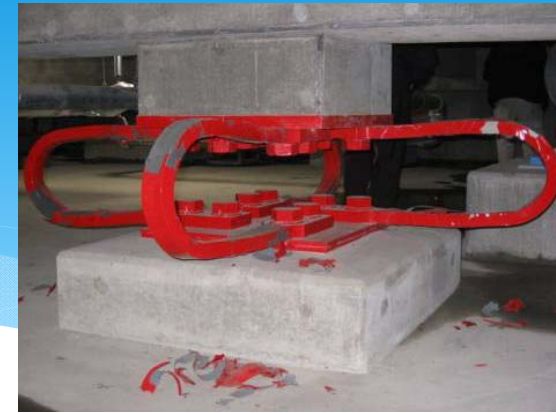
Peeled off of paint on U-shape dampers

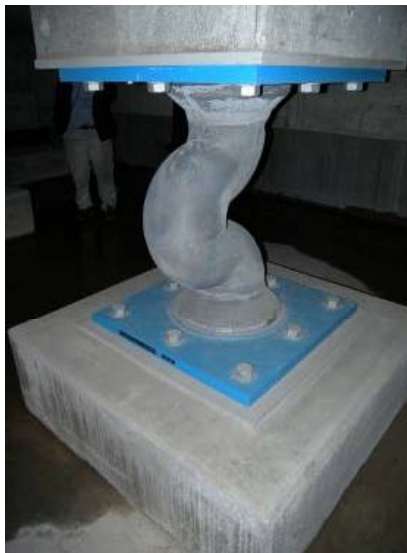
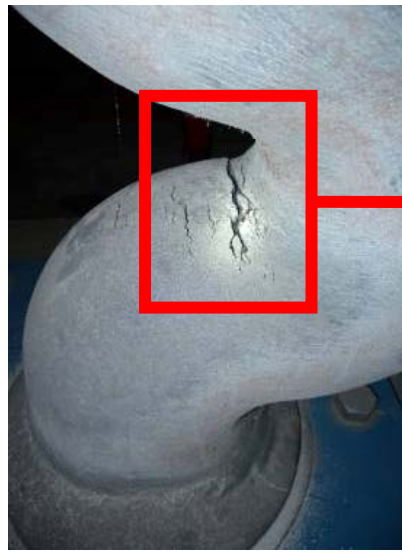
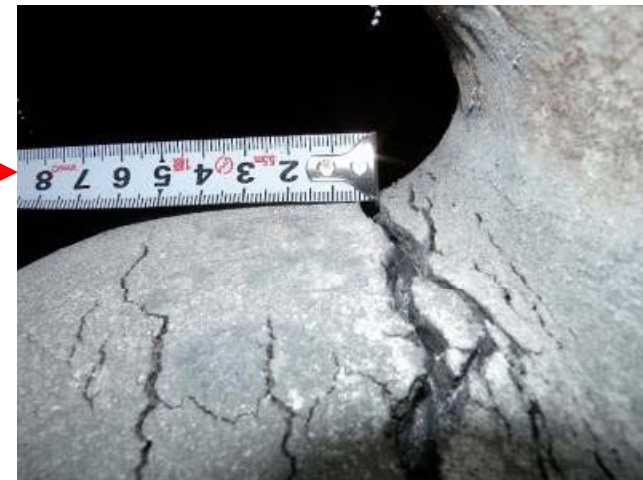
Lead damper and crack on the surface

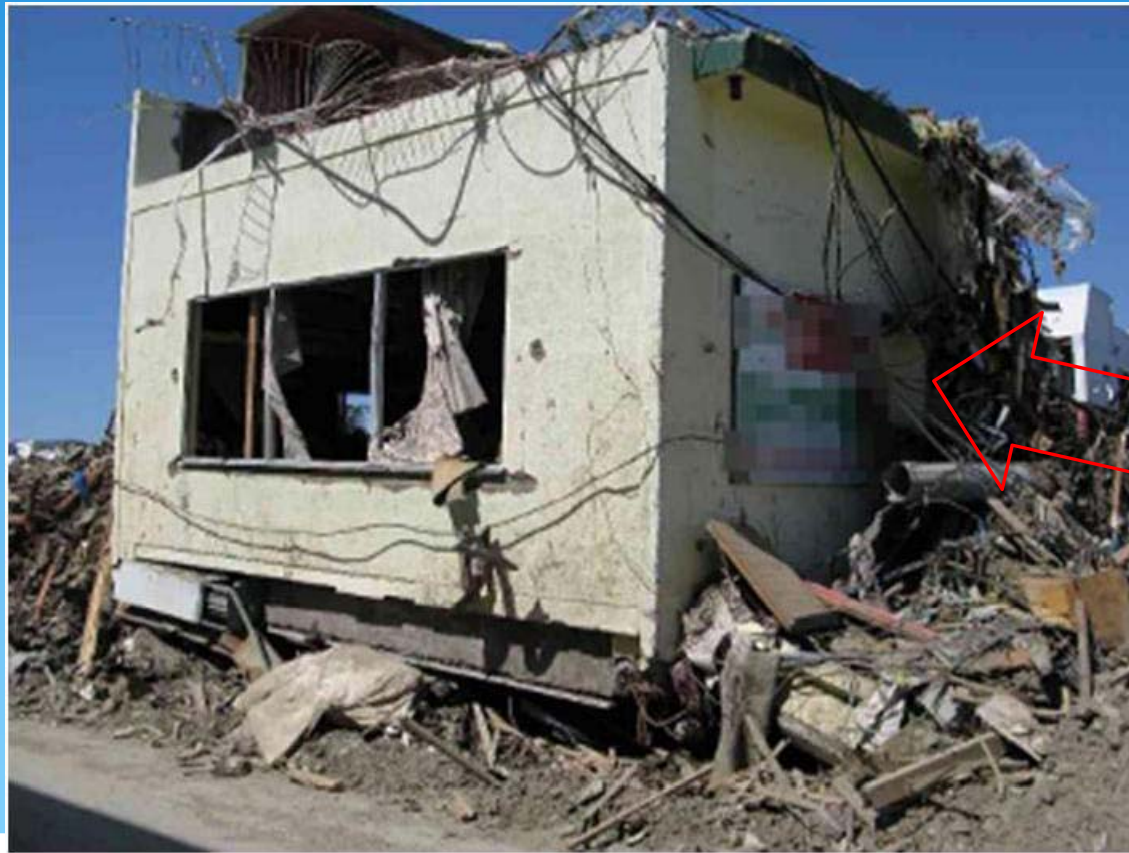
## (1) Collapse of first floor

A case where column capitals and bases on the first floor in a building were subject to flexural failure and subsequently to **story collapse** was seen in two-story buildings.

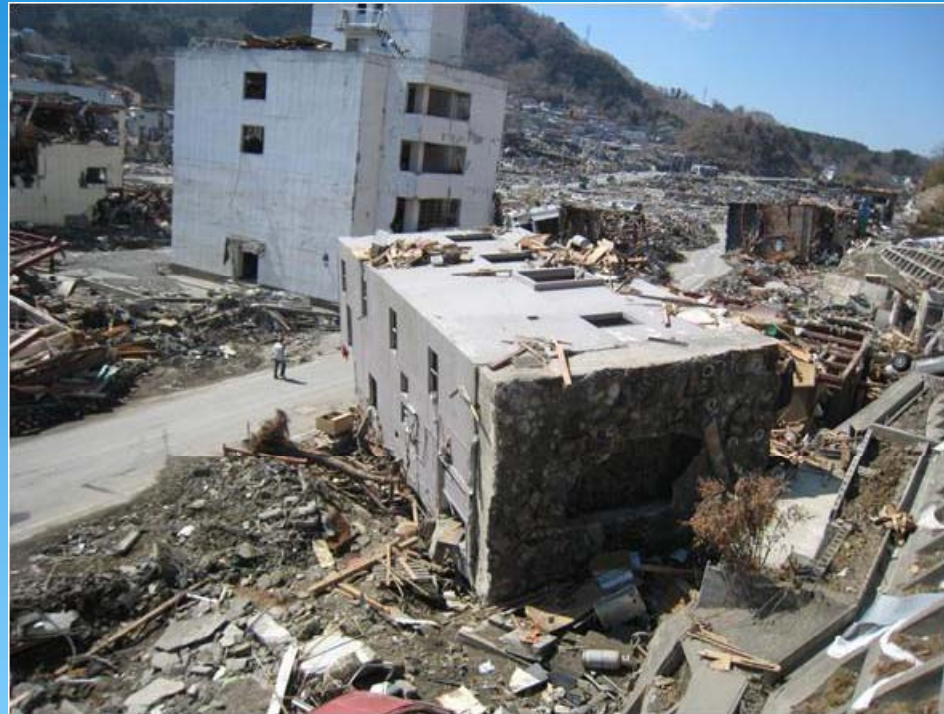
## (2) Overturning

Overturning was observed in 4-story or lower buildings. In all overturned buildings, the maximum inundation depth exceeded their height. Overturning types include building that fell sidelong and buildings that turned upside down.

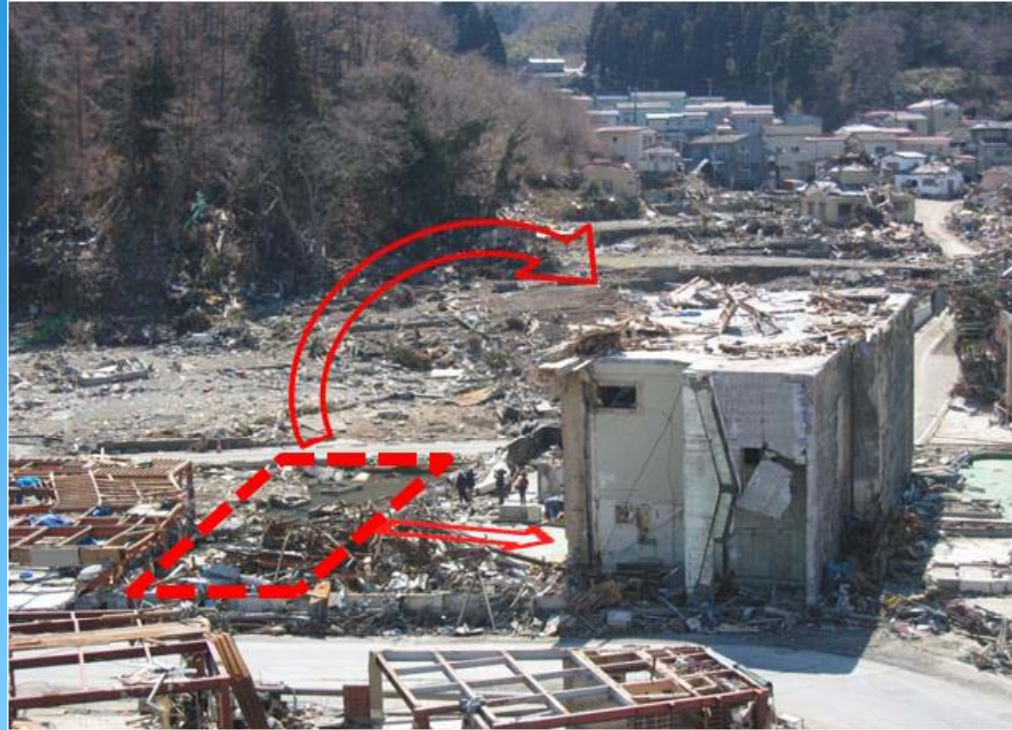
### (3) Movement and washed away

Most of the overturned buildings were moved from their original positions. It is estimated that large **buoyancy** acted on the buildings. Moved and overturned buildings left no dragged traces on the ground.

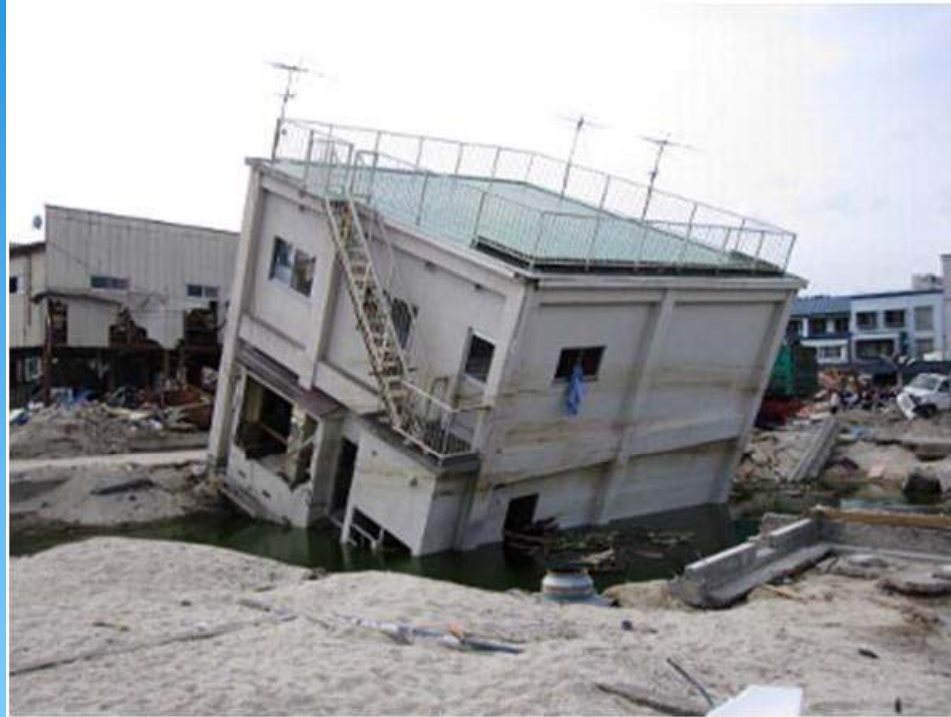
## (4) Tilting by scouring

When tsunami acted on a building, a strong stream was generated around the corner of the building, resulting in many large holes on the ground that were bored by **scouring**. In one case, a building on mat foundation fell into a hole bored by scouring.

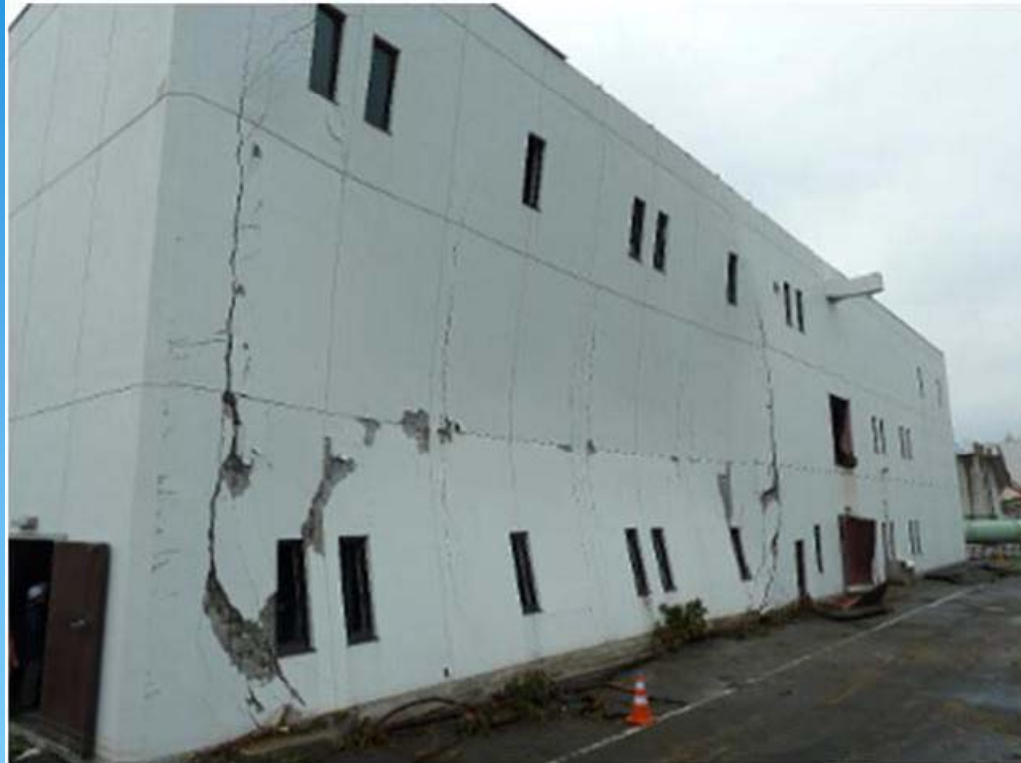
## (5) Fracture of wall

In one damaged building, a 300 mm-thick shear wall with double layer bar arrangement and a support span of more than 10 m and without no 2-story floor was bent inside by a tsunami wave pressure.

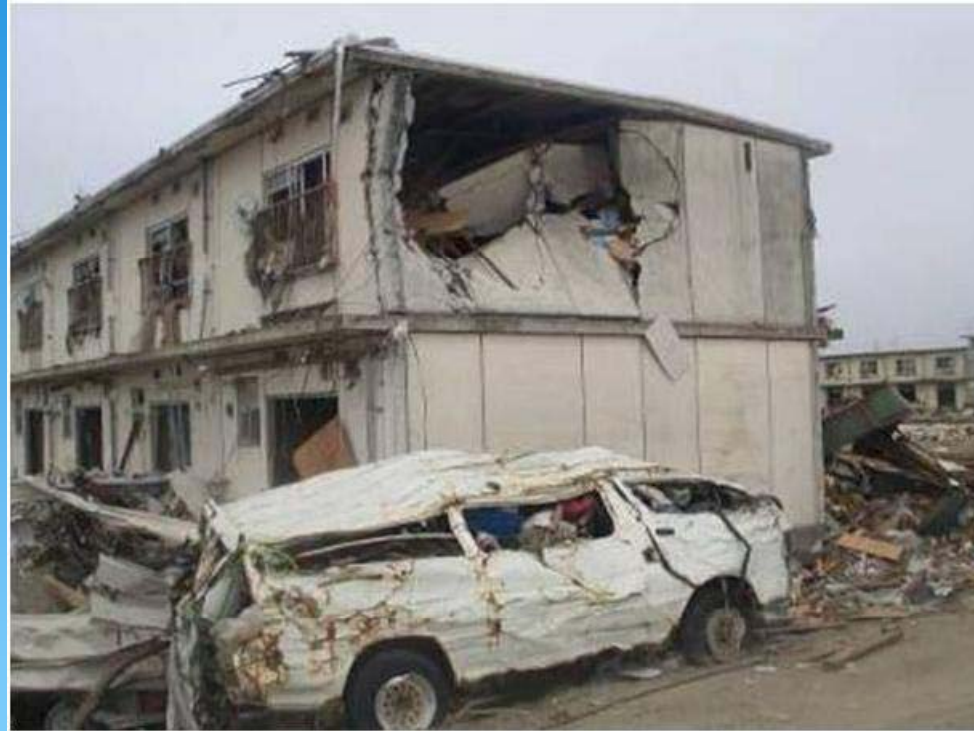
## (6) Debris impact

Debris impact was seen in most of the non-structural members such as window and ceiling materials. The number of cases of clear damage to skeletons was not large, but in one observed case, a multi-story wall in an apartment house was probably bored by debris impact .

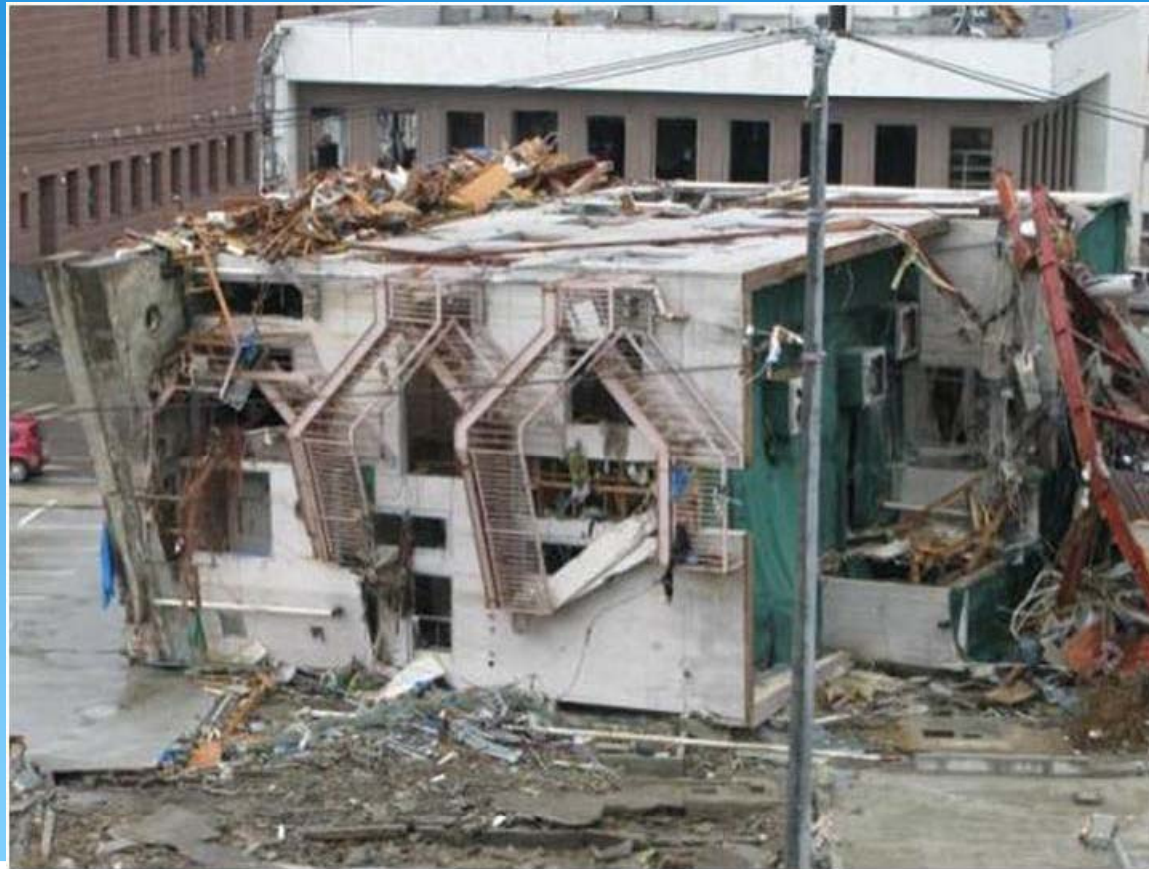
## (3) Overturning

One case, in which a whole building including foundation is overturned, was confirmed. Most of the ALC panels of claddings were left.

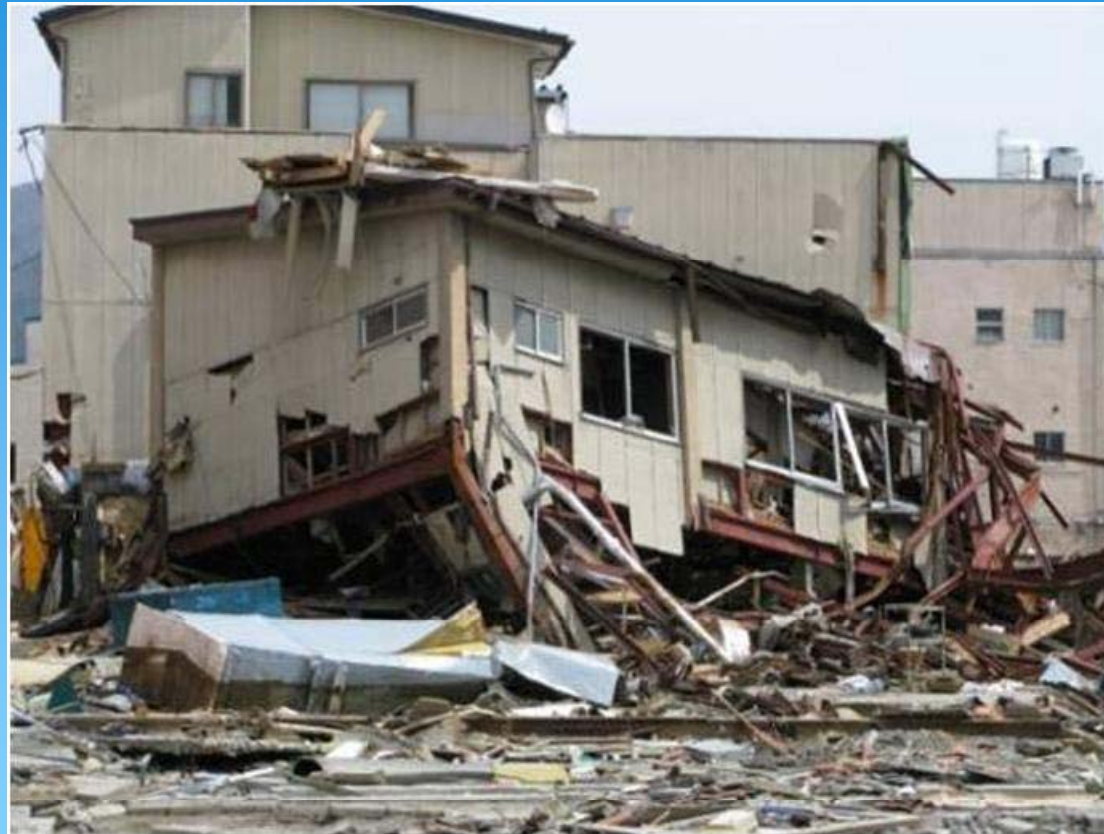
## (4) Collapse

Damage cases of skeleton collapse include story collapse of the first floor in a 2-story steel building and partial collapse of a warehouse on the coast.

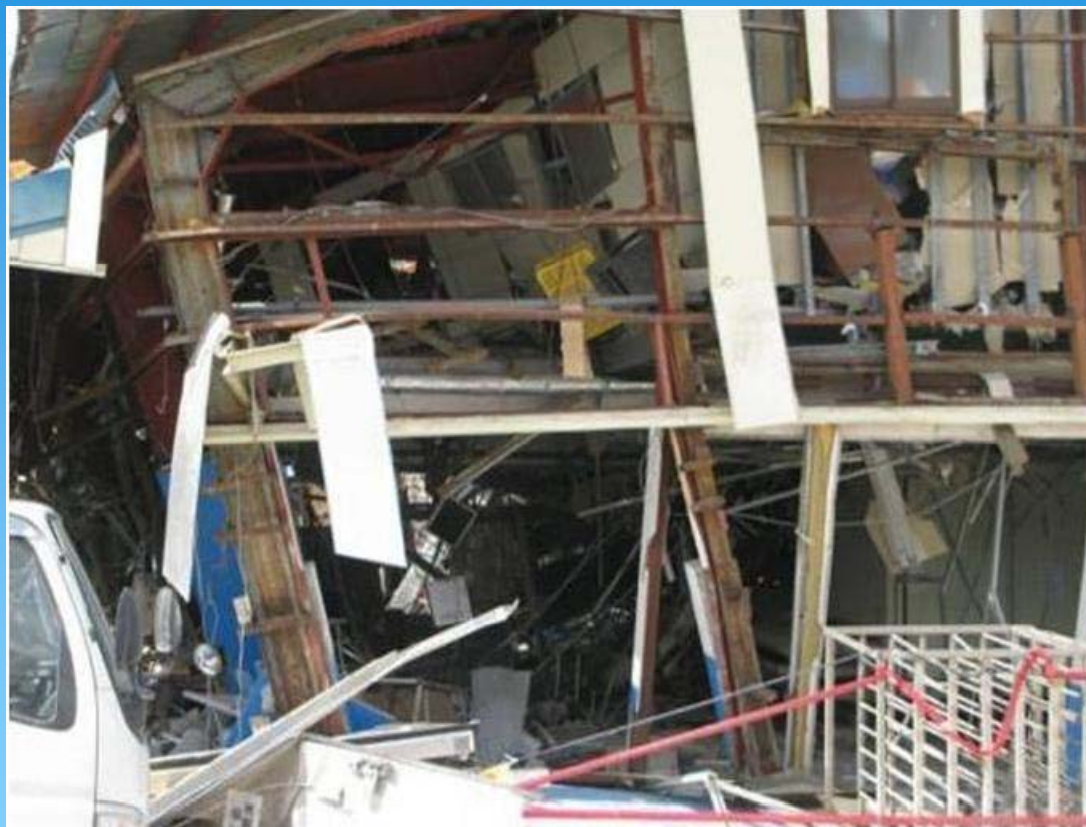
## (5) Large residual deformation

Slight tilting was often observed in steel buildings with only a skeleton left. In one case, a gabled roof frame building did not collapse despite large residual deformation.

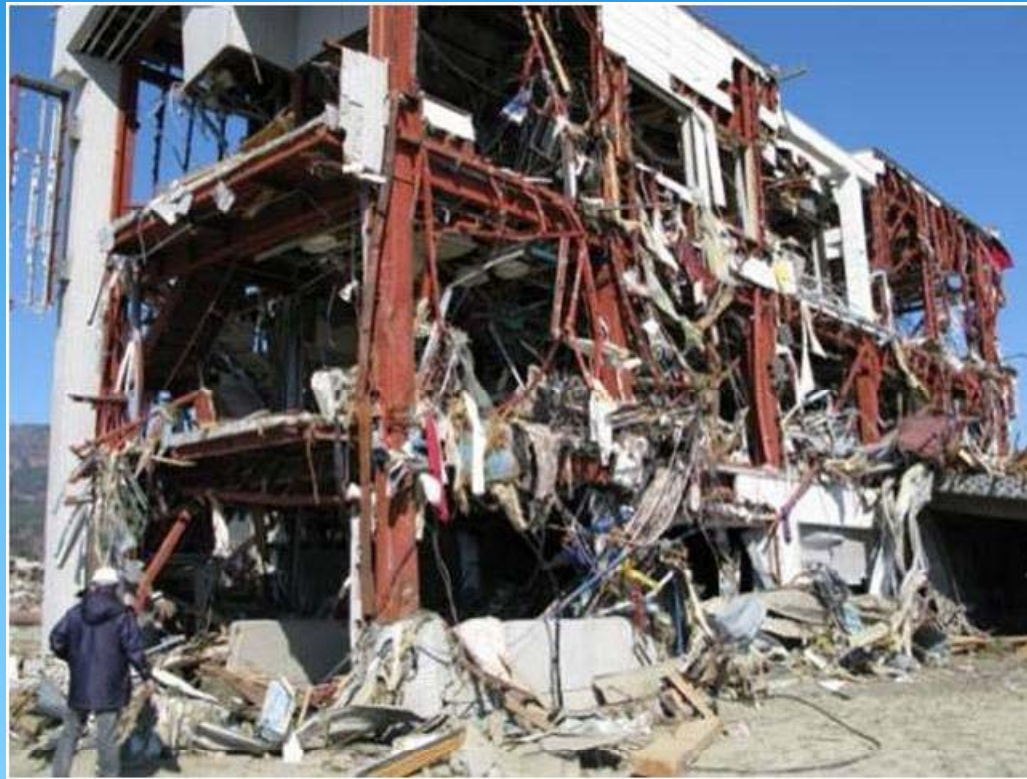
## (6) Full fracture and washed away of cladding and internal finishing materials

Cladding materials such as ALC panel were almost fully fractured and washed away, and a steel frame as a skeleton was left. This case was often seen.

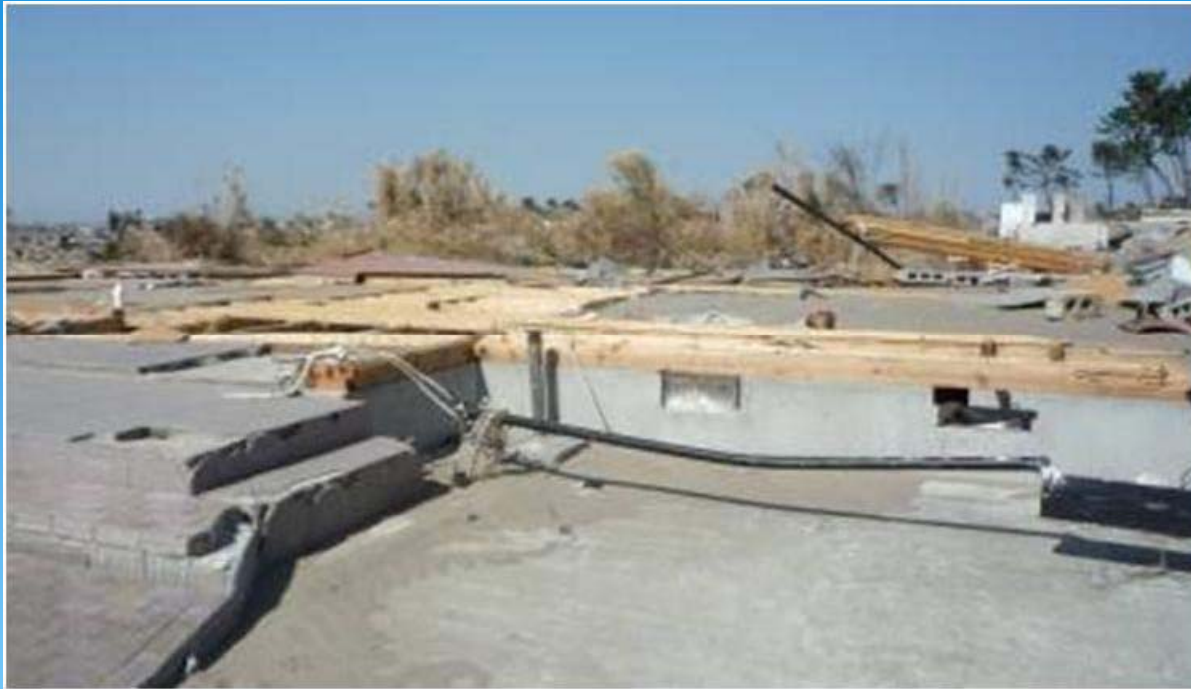
In the case of a maximum inundation depth **more than about 6 m** (equivalent to a height of eaves of 2-story wooden house), the number of 1-story and 2-story Wood Houses that remained was almost zero.

In the case of a maximum inundation depth of **about 1 m**, most of wood houses remained.

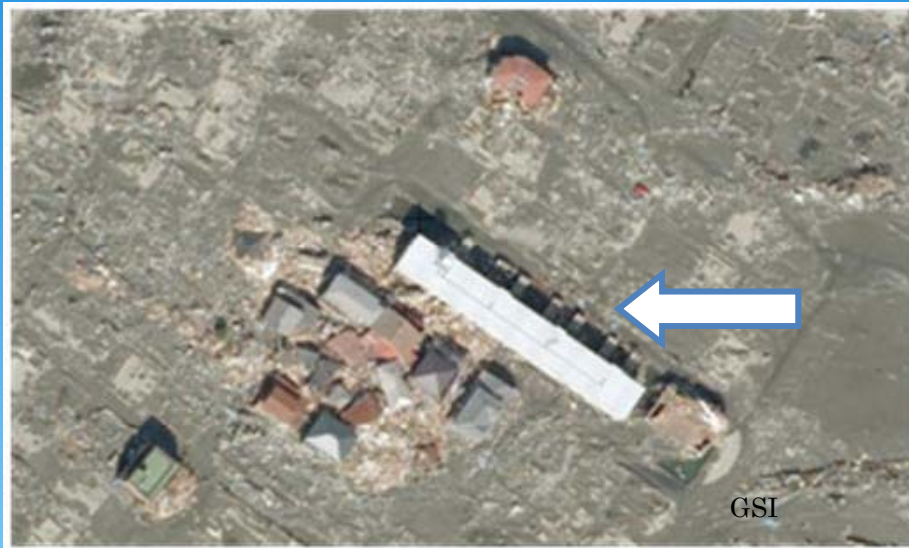
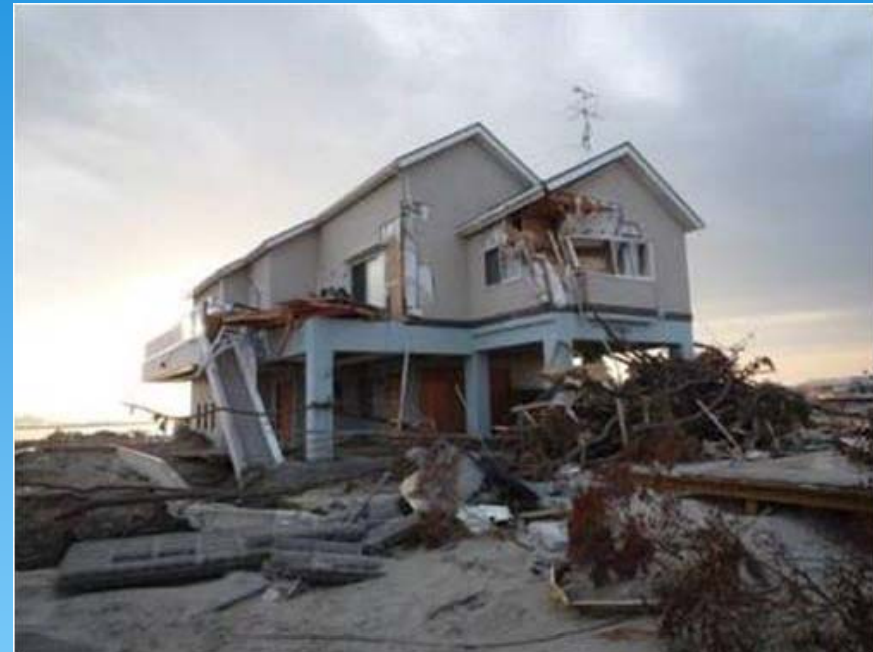
A tsunami wave force was reduced possibly due to many openings in the direction affected by tsunami or on the whole plane, or a wooden house remained despite washout of columns and external walls in the corner of the building.
