The Tornado Damage Mitigation Project

Japan's Building Research Institute (BRI) conducts activities ranging from research and development on housing, building and urban planning technology, to international training on seismology and earthquake engineering. Against the background of significant tornado damage in Japan earlier this year, this article introduces some of the BRI's initiatives in tornado research and the launch of a frontline tornado research project to help reduce damage to buildings.

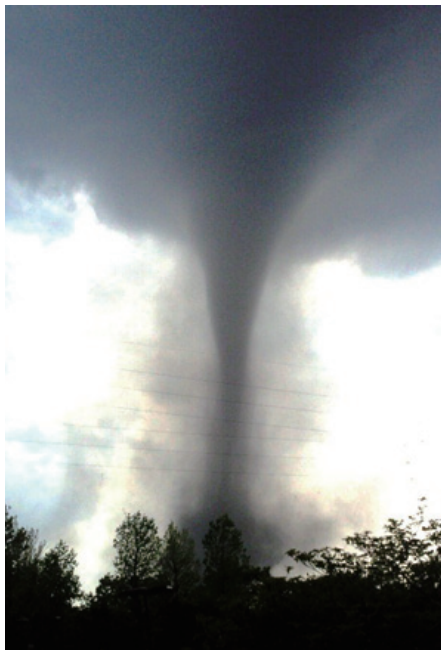
Photo 1: A tornado in Tsukuba, Ibaraki Prefecture, on May 6, 2012

On May 6, 2012, a mass of cold air entered the skies above Japan. At the same time, warm, moist air was moving towards a low-pressure area over the Sea of Japan. Compounded by elevated ground temperatures due to solar radiation, this caused major atmospheric instability from the central Tokai area all the way up to Tohoku in the north, resulting in cumulonimbus clouds accompanied by lightning, transient winds and hailstorms. These weather conditions led to multiple tornado outbreaks in Ibaraki, Tochigi and Fukushima Prefectures, causing casualties and substantial damage to countless homes and other buildings (see **Photo 1**).

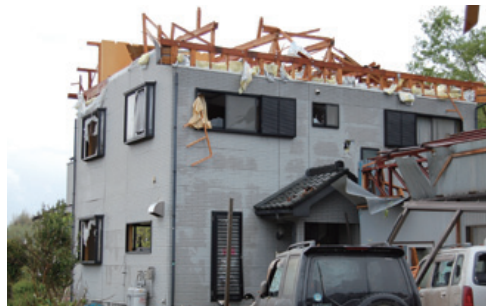
Photo 2: Destruction caused to a wooden house

In order to get a picture of the damage caused to buildings by the tornado that hit Tsukuba, Ibaraki Prefecture, on May 6, 2012, the Building Research Institute joined forces with the National Institute for Land and Infrastructure Management and began conducting a field survey from that same day. In addition to typical damage recorded in the aftermath of other tornadoes (scattering of exterior materials, collapse of wooden roof trusses, impact from flying debris, etc., see **Photos 2 and 3**), the survey found new types of damage that had not been observed previously. **Photo 4** shows a two-story wooden house whose foundations became detached from the ground, causing the entire structure to overturn. **Photo 5** meanwhile shows a five-story reinforced

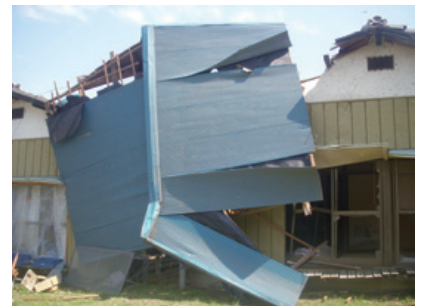
Photo 3: Impact from flying debris (roof)

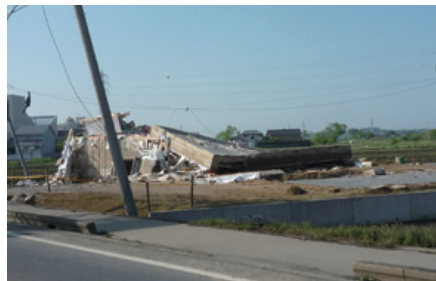
Photo 4: A wooden house overturned with its foundations still attached

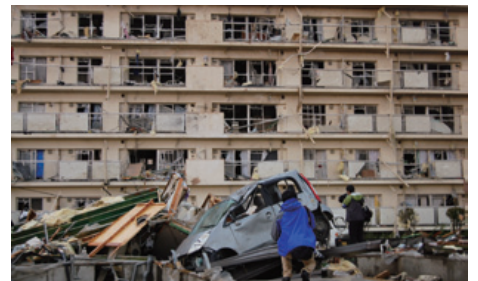
Photo 5: An apartment building with extensive damage to non-structural elements

concrete apartment building, which sustained extensive damage to non-structural elements such as windows, window frames and aluminum balcony handrails. The buildings in these two photographs are thought to have been in or around the path of the tornado. Nonetheless, the reasons for such extensive damage and the magnitude of pressure caused by transient winds remain unclear. From the standpoint of wind engineering, throwing light on phenomena such as these is proving extremely challenging.

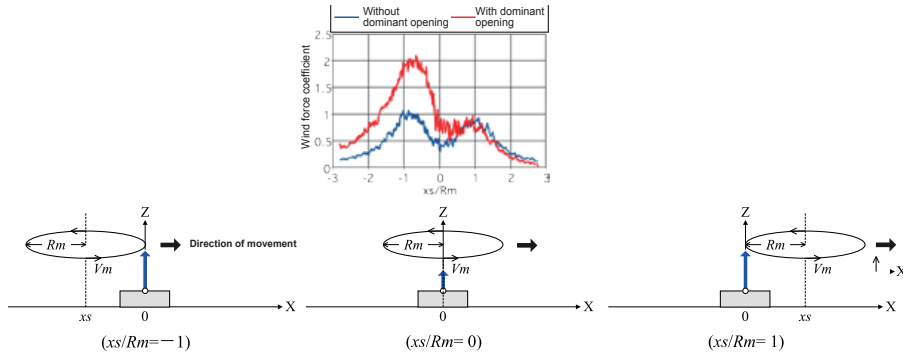
Figure 4: Vertical force from a passing tornado

Figure 4 shows wind force characteristics acting vertically on the roof of the building. The horizontal axis shows the moving position of the simulator in relation to the center of the model (x_s) divided by the core radius (R_m). The findings indicate that, irrespective of dominant opening, wind force is at its maximum when x_s/R_m is -1 or 1. This means that the center of the building would be subjected to the maximum tangential wind speed when the tornado is approaching the building and immediately after the tornado has passed. In terms of dominant opening, the wind force is approximately twice as strong when a dominant opening is present. This suggests that preventing large openings from forming in the wall as the tornado approaches would effectively reduce the force of the wind on the roof.
