# Building damage by the 2011 off the Pacific coast of Tohoku earthquake and coping activities by NILIM and BRI collaborated with the administration

Isao Nishiyama (NILIM),  
Hiroshi Fukuyama (BRI),  
Yasuo Okuda (BRI), and  
Izuru Okawa (BRI).

## 2. Building Damage due to Earthquake Ground Motions

# 3. Damage to Buildings in Inundation Areas due to Tsunami

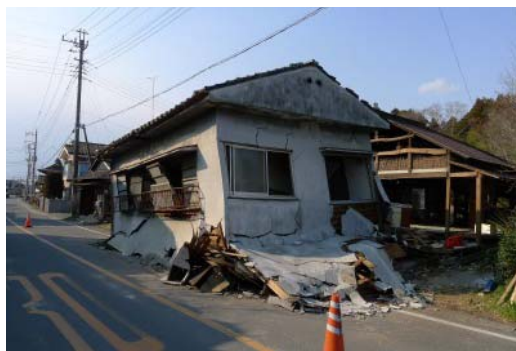
Collapse of 1<sup>st</sup> story

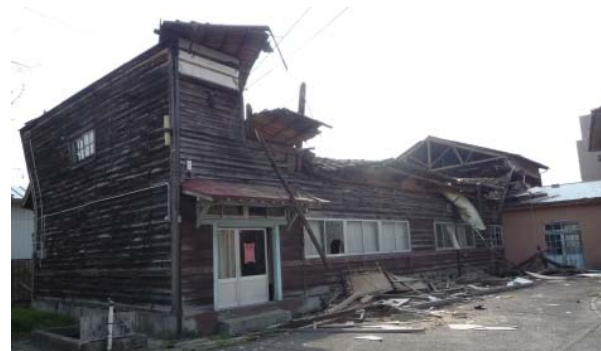
Collapse of 2<sup>nd</sup> story

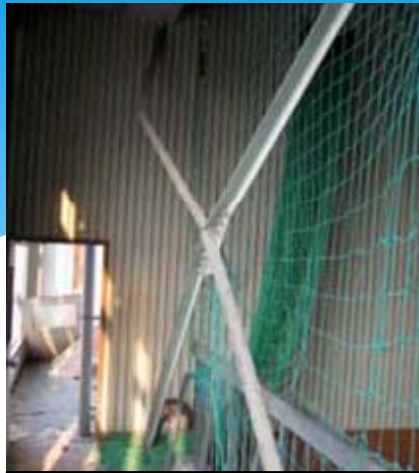
Buckling of brace

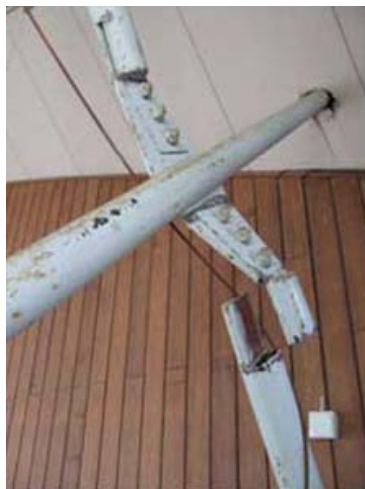
Rupture of brace at joint

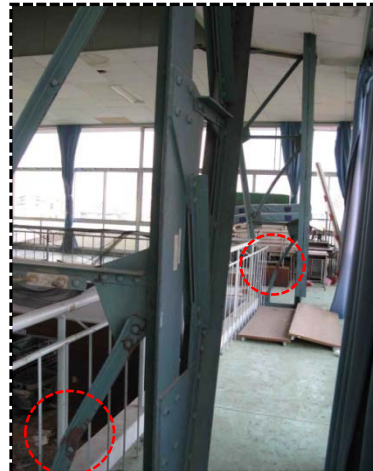
Buckling of diagonal member of latted column

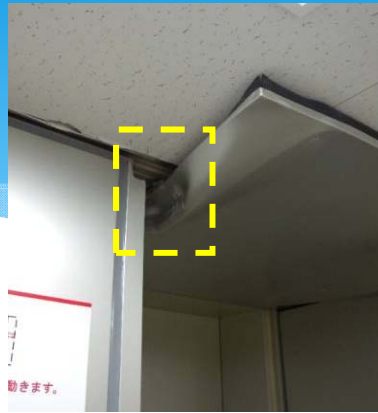
Damage to expansion joint

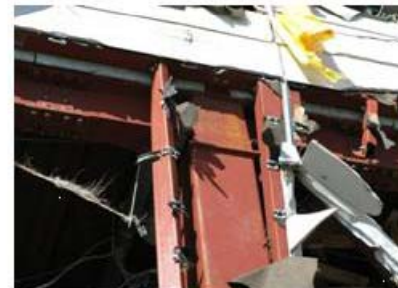
写真3 建物の柱梁部材

- ・ 外装材は、ほぼ全て剥落している
- ・ 1階柱口-300×300、桁行梁 H-300×150×6.5×9、梁間梁 H-306×199×7×11
- ・ 津波作用面の反対側に隣接する RC 造 2階建て躯体の被害は軽微であった
