# Building damage by the 2011 off the Pacific coast of Tohoku earthquake and coping activities by NILIM and BRI collaborated with the administration

Isao Nishiyama (NILIM),  
Hiroshi Fukuyama (BRI),  
Yasuo Okuda (BRI), and  
Izuru Okawa (BRI).

## 2. Building Damage due to Earthquake Ground Motions

# 3. Damage to Buildings in Inundation Areas due to Tsunami

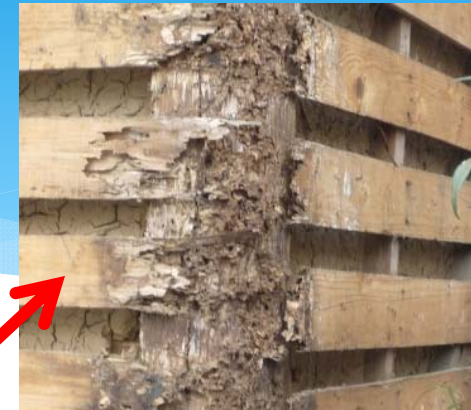
Collapse of 1<sup>st</sup> story

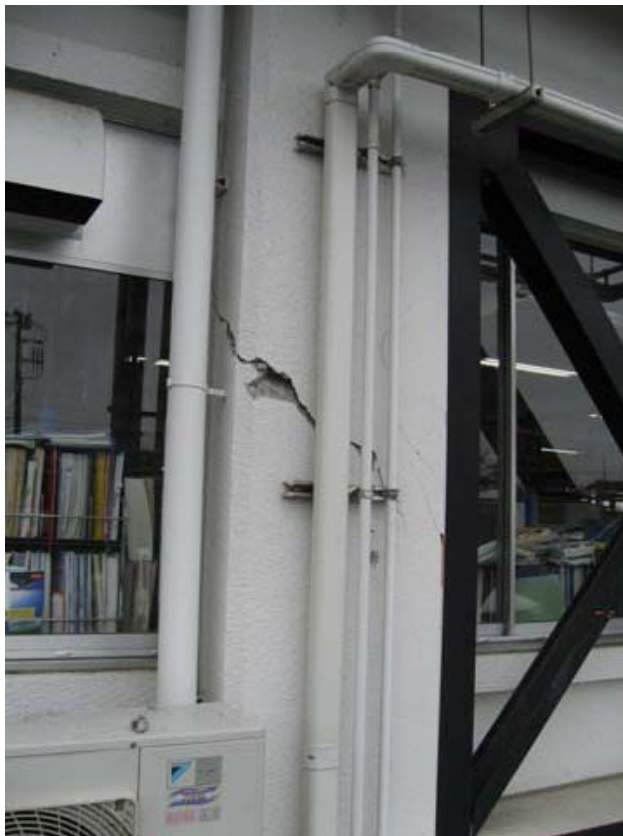
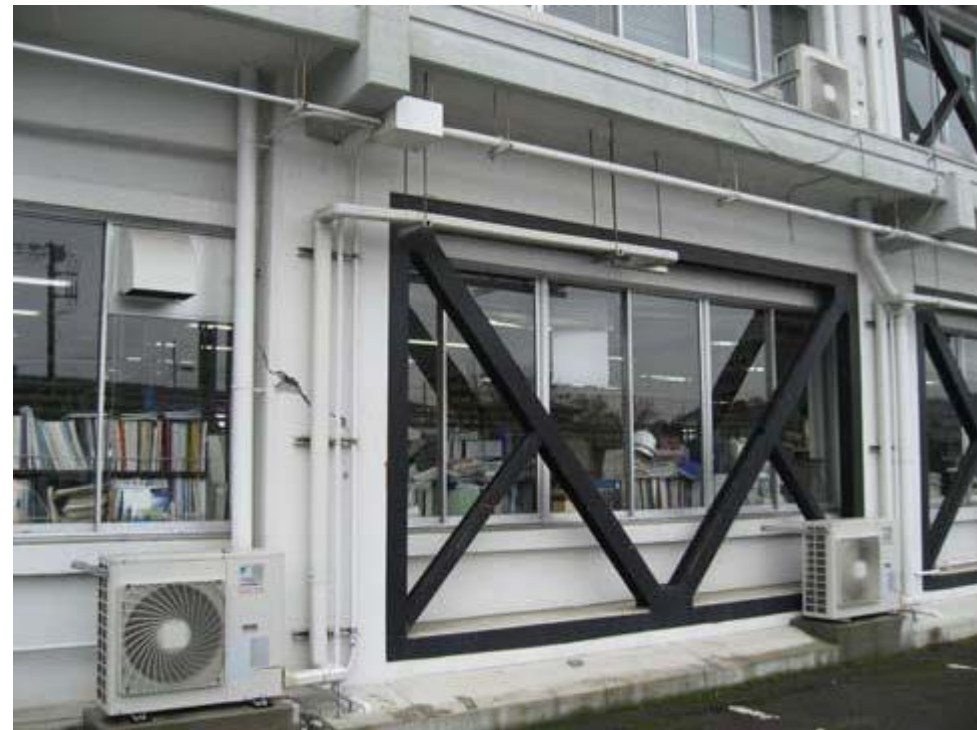
- Most of the retrofitted buildings performed well to secure human lives by preventing collapse.
- Damage were observed in some retrofitted buildings

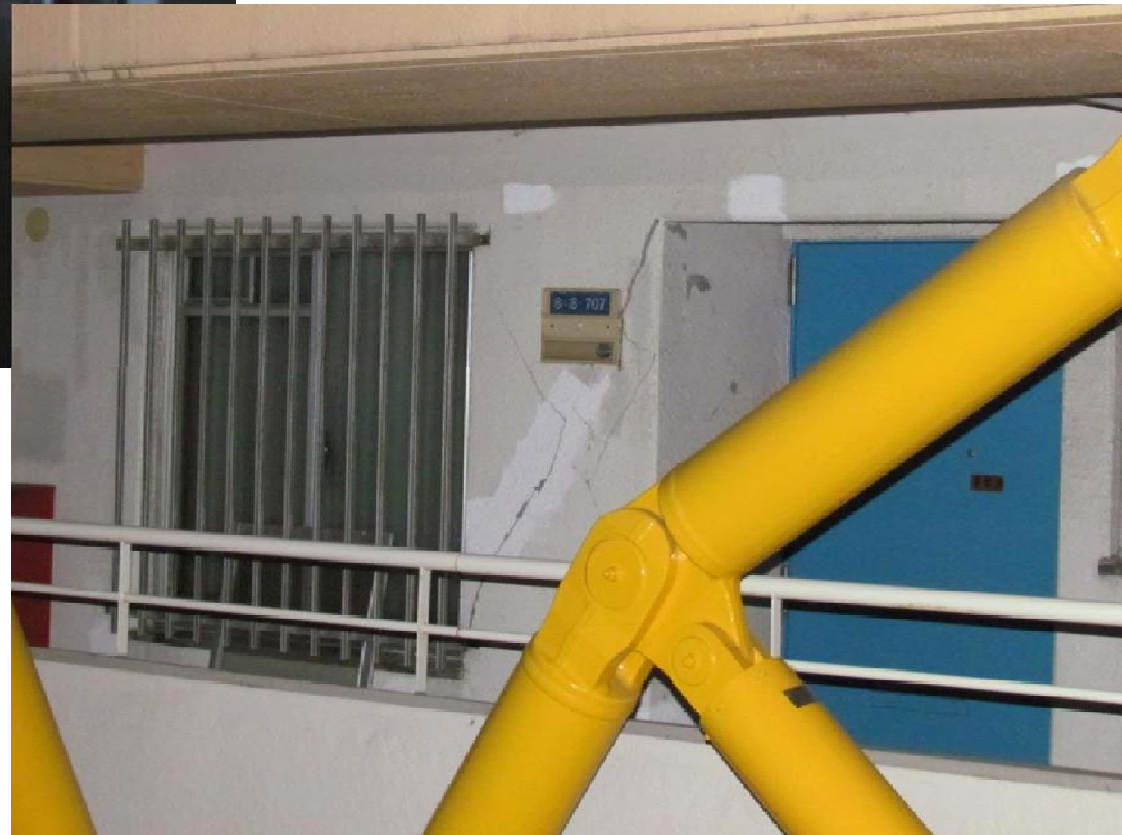
Damage to non-structural walls of residential buildings retrofitted by oil damper

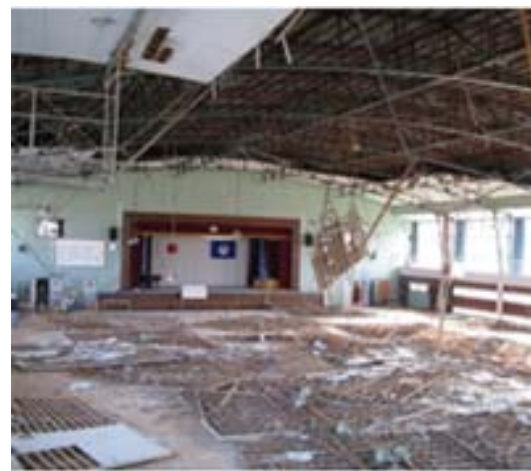
Dropping of extensive ceiling materials and exterior finish materials

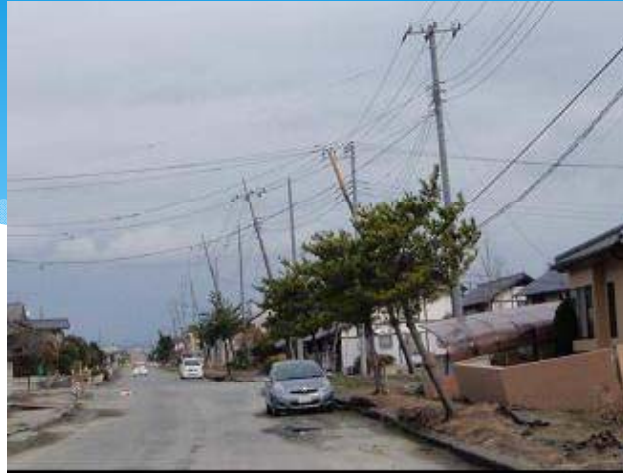
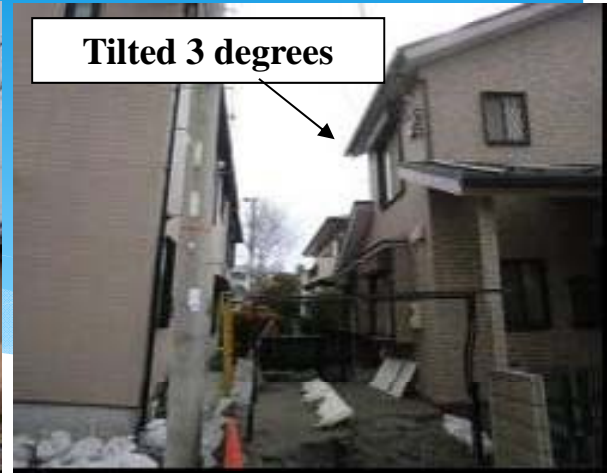
Sand boiling and tilting of house

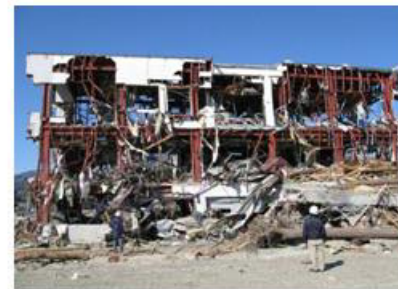
写真1 建物外観

建物番号	RT-12	調査日	2011年4月6日
名称	診療所		
所在地	陸前高田市高田町馬場前	建設年	不明
用途	病院・診療所	津波避難ビル	指定なし
構造種別	S造 (ラーメン構造)		
建物規模	階数	3階 (地下 階)	高さ: 9.6m
	平面寸法	21.5m x 7m	
建物位置	海岸からの距離	約1200m	標高 5m (GPS)
	立地条件	陸前高田駅前交差点近く。平坦な市街地	
最大浸水深	9m	周辺建物の痕跡より	
津波後の状況	建物の状態	原位置に残存	1×5スパン、外装材が脱落しているが躯体に損傷は見られない
	躯体の被害	被害なし	
	非構造部材の被害	被害あり	外装材の脱落
備考

- ・ 外装材は、ほぼ全て剥落している
- ・ 1階柱口-300×300、桁行梁 H-300×150×6.5×9、梁間梁 H-306×199×7×11
- ・ 津波作用面の反対側に隣接する RC 造 2階建て躯体の被害は軽微であった
